TS-PIC-91028
July 1991

EPA Site Analysis
Hi Mill Manufacturing Co.
Highland, Michigan

Site Analysis
Hi Mill Manufacturing Co.
Highland, Michigan

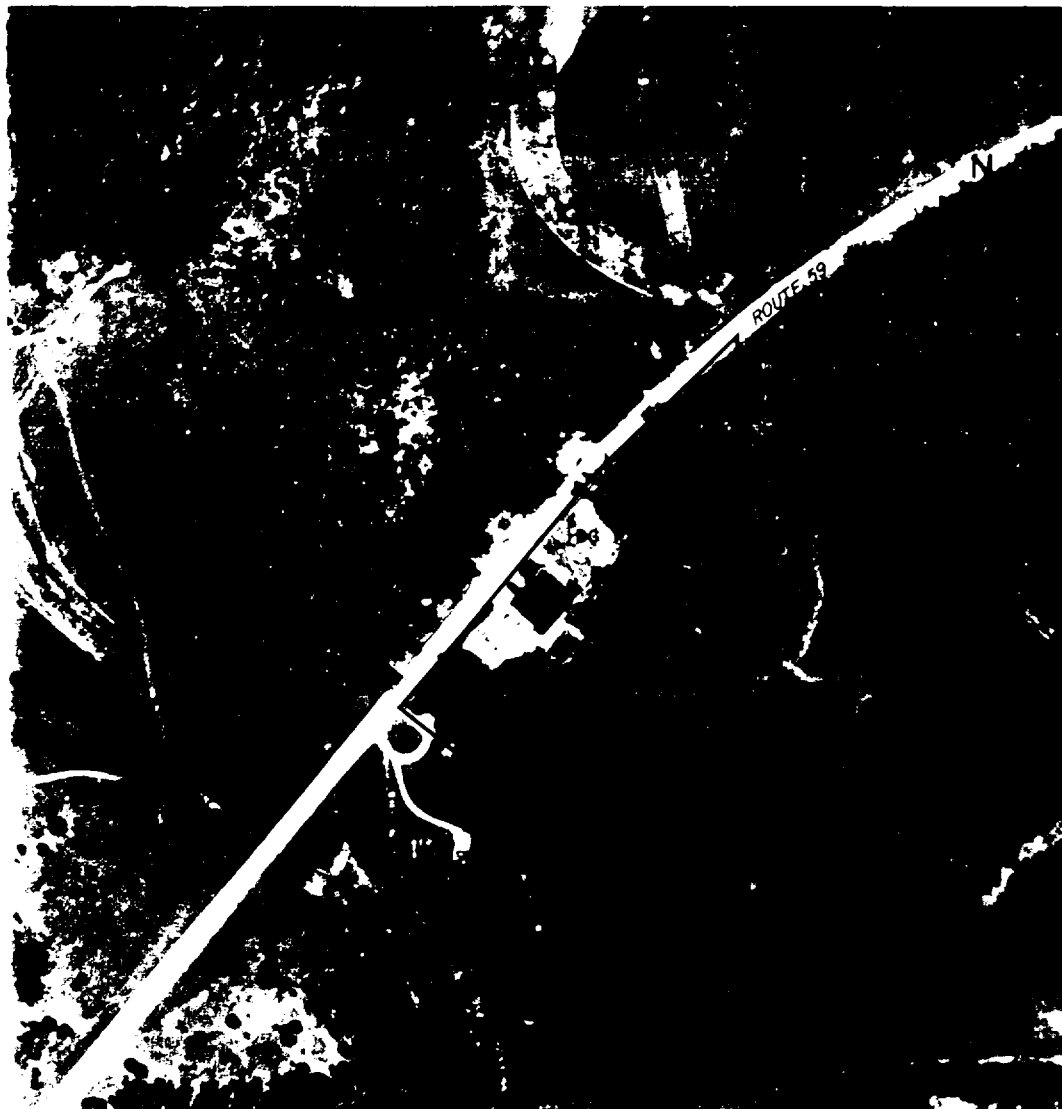
FIGURE 3
MILL MANUFACTURING CO.

Figure 3 represents the first available photographic coverage of the Hi Mill Manufacturing Company. Two buildings (B1 and B2) are present, and a considerable amount of disturbed ground (DG) is visible northeast of the buildings. This may be related to future construction onsite. A small pond at the southeast corner of the site does not appear related to site activity at this time. The extent of the pond cannot be determined because of the heavy tree canopy.

A drainage analysis was performed for this year, with any significant changes noted on subsequent years of photography. Target Pond* is located directly east of the Hi Mill Manufacturing Company. Three streams enter Target Pond: two from the north and one from the west. Target Pond drains south into Waterbury Lake. Streams west of the site flow south and southeast towards Waterbury Lake.

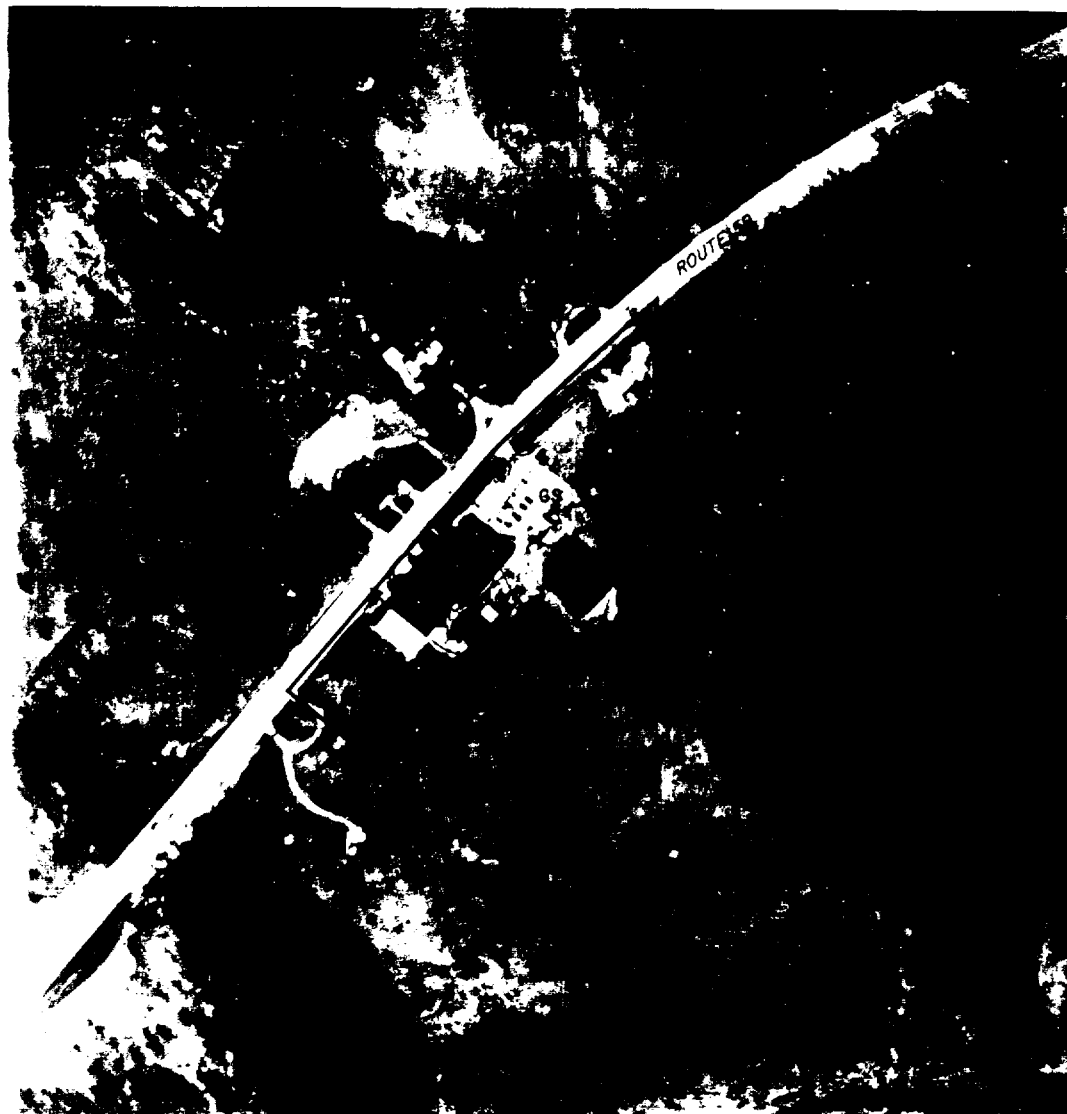
FIGURE 4
MILL MANUFACTURING CO

B1 undergoes many changes during the course of this analysis. Whether additions have been built onto the original structure seen in 1957, or if an entirely new building has been constructed, cannot be determined. The structure will continue to be annotated as B1. B2 remains and a parking lot (not annotated) northeast of the buildings exists where disturbed ground was evident on the 1957 photography. Much of the northeastern section of the site has been deforested.

A fence blocks access into the site from Route 59. Fencing is not visible around the south or east sides of the site.

A lagoon (L1) is seen onsite for the first time during this year of analysis, and contains liquid (not annotated). A linear ground scar (GS) and a ditch lead towards the northern corner of the lagoon. Leaf-off conditions now permit full visibility of the pond southeast of the lagoon. The northern extent of the pond is adjacent to the lagoon, but the two do not appear to be joined. However, the shape of the northern half of the pond, plus the presence of disturbed ground between the lagoon and the pond, indicates the possibility that some connection between the two may exist. It should also be noted that the tone (not annotated) of the liquid within the northern half of the pond differs from that of the southern half. A difference in tone is not visible on any other year of photography analyzed.

Possible refuse (R), light-toned and coarse-textured, is piled west of the lagoon. A ditch lies south of the possible refuse. This ditch extends from B1 and turns north towards the lagoon but does not appear to connect to the lagoon. A pool of liquid (LQ) is present south of the ditch.

Piles of dark-toned (DK) material (M) are visible southwest of B1.

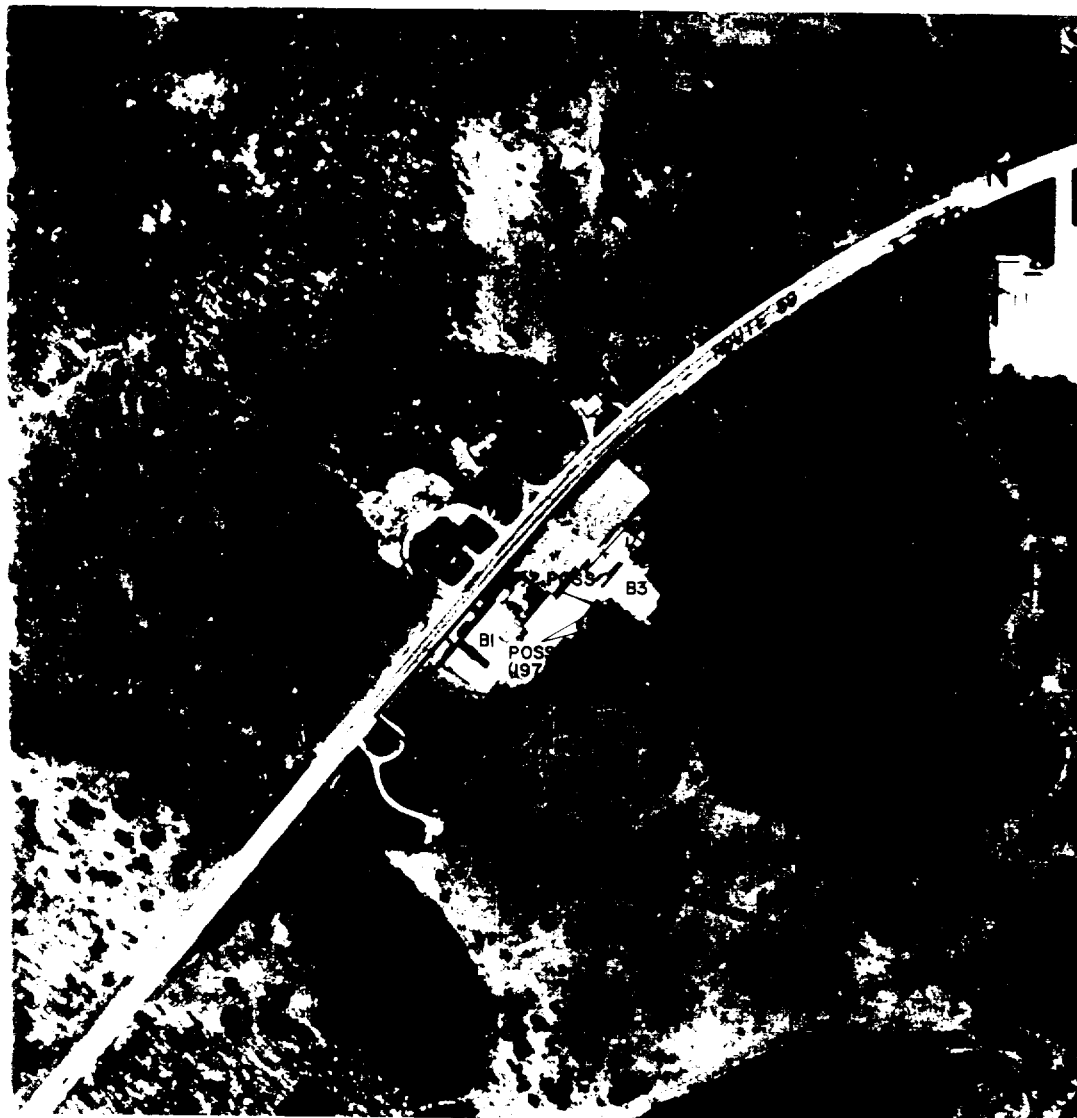
FIGURE 5
MILL MANUFACTURING CO.

Between 1967 and 1970, a third building, B3, was constructed on the northeast side of L1. B1 and B3 do not undergo any major changes throughout the remainder of the analysis. Therefore, they will be annotated but no longer discussed except in relation to other features onsite. B2 was removed between 1967 and 1970.

Fencing along the Route 59 entrance to the site no longer exists. A fenced area northwest of B3 is present. Possible refuse, medium-toned and coarse-textured, is visible outside the fence, north of B3.

L1 again contains liquid and the southwest and southeast sides (not annotated) appear to have been straightened or walled. In 1970, three possible excavations (not annotated) were visible southwest of the lagoon, next to a probable pool of liquid. Both are no longer visible. Also seen in 1970, adjacent to the excavations, was a possible pipe (P) which appeared to originate from B1 and lead towards L1. The possible pipe is no longer visible. The ditch and ground scar, seen in 1967 northeast of L1, are no longer present due to the construction of B3. Two possible pipes are visible on the northwest side of L1. Another possible pipe was seen at L1 in 1970 but cannot be detected on this year of photography. As in previous years, the pond south of L1 does not appear to connect to L1. A light-toned (LT) material is now seen along the west edge of the southern half of the pond.

The long ditch and the pooled liquid, seen in 1967 south of B1, are no longer present. A ground scar, seen on the 1970 photography in the former location of the ditch, has now revegetated. Possible refuse, seen in 1967, is no longer present; its former location is covered by additions to B1.

A group of possible containers (C) is noted within the fence southwest of B1. The piled dark-toned material seen in this portion of the site in 1967 is no longer present. Fencing now exists south and east of B1.

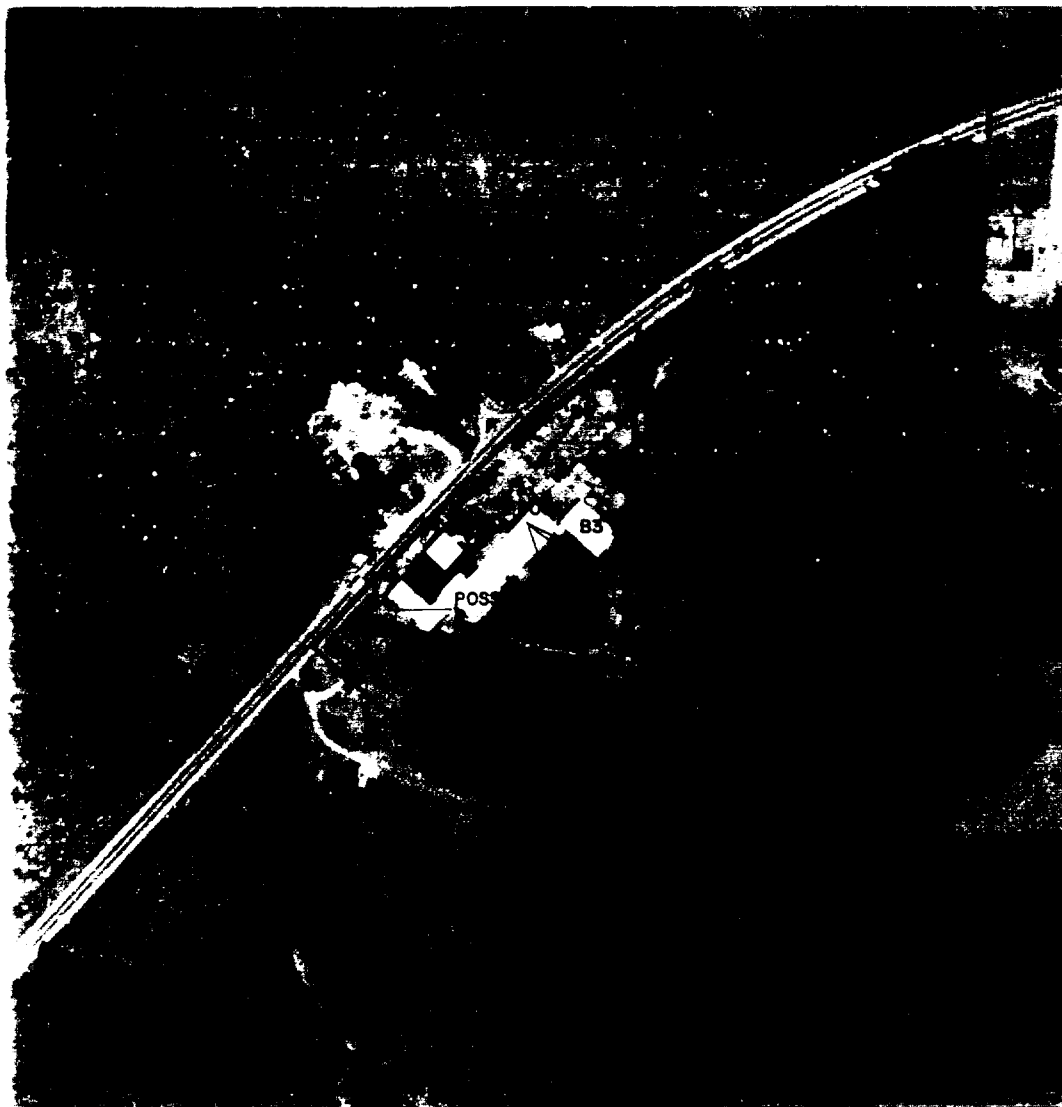
AUGUST 17, 1978

An area of disturbed ground, which extends to Target Pond, is now seen in the north portion of the site, outside the site's fence. The presence of this area may be related to water supply lines which reportedly extend northwest from B1 through the parking lot towards Target Pond.*

Fencing has been altered, and now forms a triangular shape around the site. Possible refuse, seen in 1975 adjacent to B3, is no longer present.

A second lagoon (L2) now exists south of L1, and contains liquid. Ground scars (not annotated) were seen in 1976 in the current location of L2. L1 and L2 do not appear to be joined. L1 also contains liquid, and three possible pipes are seen along its northwest side. The walled sides of L1, seen in 1975, are no longer apparent but were seen in 1976.

An access road, within the fence, now exists around the southeast perimeter of the site. The construction of this road appears to have eliminated most of the small pond (no longer annotated).

Possible refuse is noted southwest of B1 where possible containers were seen in 1975.

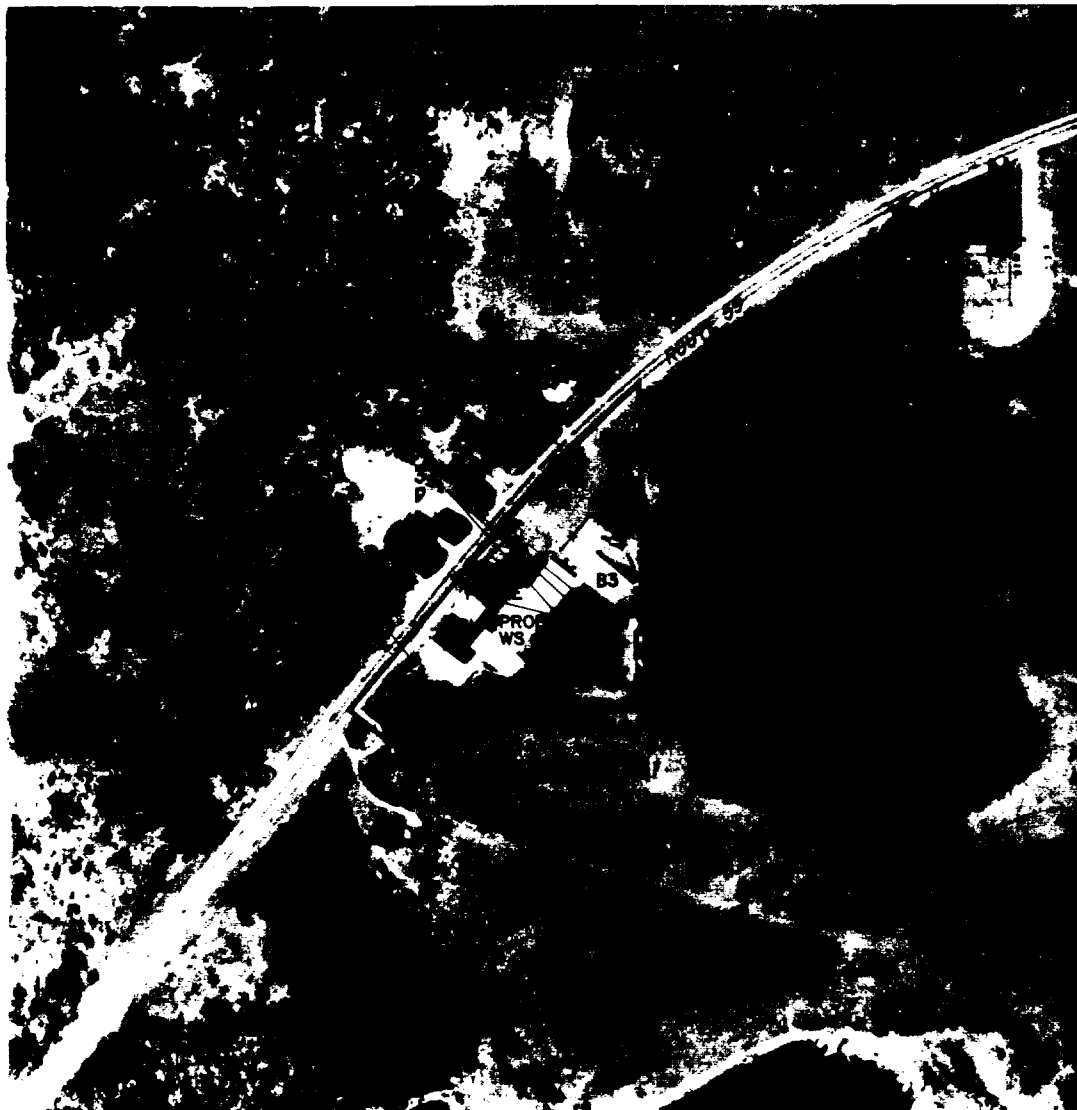
FIGURE 7
HI MILL MANUFACTURING CO.

The disturbed ground, seen in 1978 leading to Target Pond, has been paved over. A plume, visible within Target Pond, appears to originate from the former location of the disturbed area, although no outfall can be detected.

L1 and L2 continue to hold liquid. The lagoons may now be connected, as the wall between them (not annotated) appears to have partially eroded. L1 appears to have expanded on the west, and a retaining wall (not annotated) is visible on its southwest side. Two pipes are visible protruding from the retaining wall towards L1. Three possible pipes are again noted along the northwest side of L1. An area of probable wet soil (WS) is present west of L1, and a possible plume exists within L1 on its southwest side. This plume appears to originate from the westernmost pipe on the northwest side of L1. Several probable excavations (EX) are visible along the southeast side of L2 and contain liquid.

Possible refuse, also seen in 1978, remains southwest of B1.

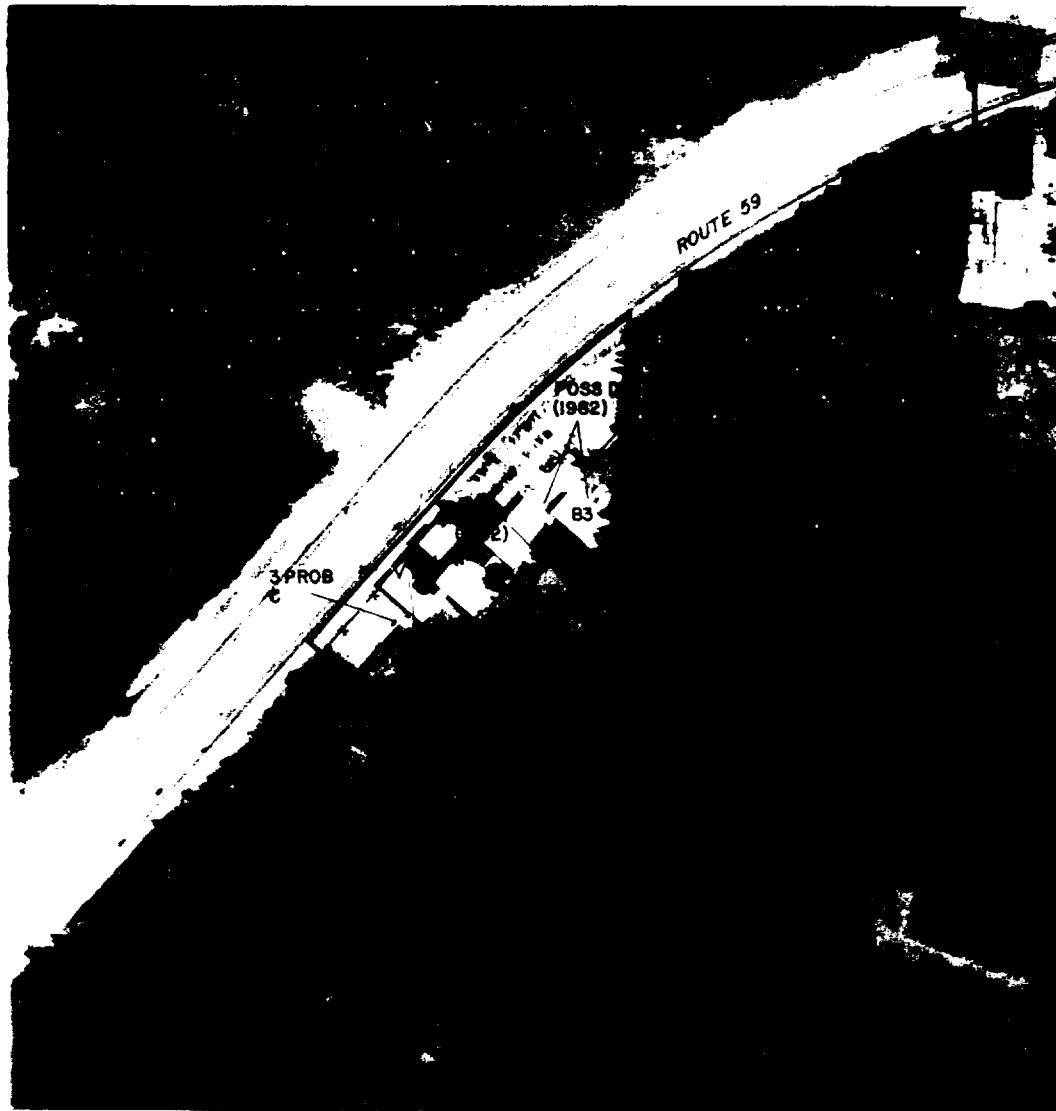
FIGURE 8
MILL MANUFACTURING CO.

A plume is no longer visible within Target Pond. Possible drums (D) were evident north and northwest of B3, within the fence, in 1982. Also, possible containers were seen in 1984 along the southeast side of B3.

L1, which is no longer present in 1988, was still in use as late as 1984. L1 was filled with liquid, and a light-toned scum (not annotated) was seen on the liquid from 1982 to 1984. A possible pipe (not annotated) on the northwest side of L1 was identified in 1982. Grading scars (not annotated) and material that was apparently being pushed into L1 were identified in 1984, indicating the possibility that this lagoon was in the process of being filled.

L2 was present and filled with liquid in 1982 and 1983. The 1983 source material revealed a possible breach between L1 and L2 at the west side of L2, which first appeared to be eroded in the 1980 photography. By 1984, L2 had been removed and the entire southeast corner of the site was graded. A shallow pit filled with liquid was visible in 1984 at the former location of L2.

In 1988, an area of wet soil is visible at the location of the former lagoons. A mound lies between the two areas of wet soil, partially over the former location of the lagoons. A ditch, present in 1982, extended from the mound to the area of wet soil to the north. A linear ground scar, in the location of the former pond, is now noted east of the wet soil. The probable excavations and a possible plume seen in 1980 were no longer present by 1982. However, a possible pipe (not annotated) was seen on the northwest side of L1 in 1982.

A possible pipeline was seen east of B1 in 1982. In 1983 a probable pipeline farther west was present. These pipelines appeared to extend from B1 towards the site boundary and were no longer visible in 1984.

Additional fencing was installed in the southwest portion of the site between 1983 and 1984 in order to enclose an addition to the site. A third lagoon, L3, appeared inside this addition in 1984 and contained liquid. Like L1, the liquid within L3 exhibited a light-toned scum. This lagoon was filled between 1984 and 1988, and a ground scar (not annotated) is seen on the 1988 photography in its former location. A large mound, possibly composed of the earthen material extracted during the creation of L3, is visible south of L3's former location. Probable channelized drainage leads southwest from L3's former location to a point outside the site boundary.

The area southwest of B1 has been paved. Approximately three probable containers, light-toned and cylindrical, are seen inside the fence south of B1, and a vertical tank (VT) is noted adjacent to B1. The possible refuse seen in 1980 is no longer present.

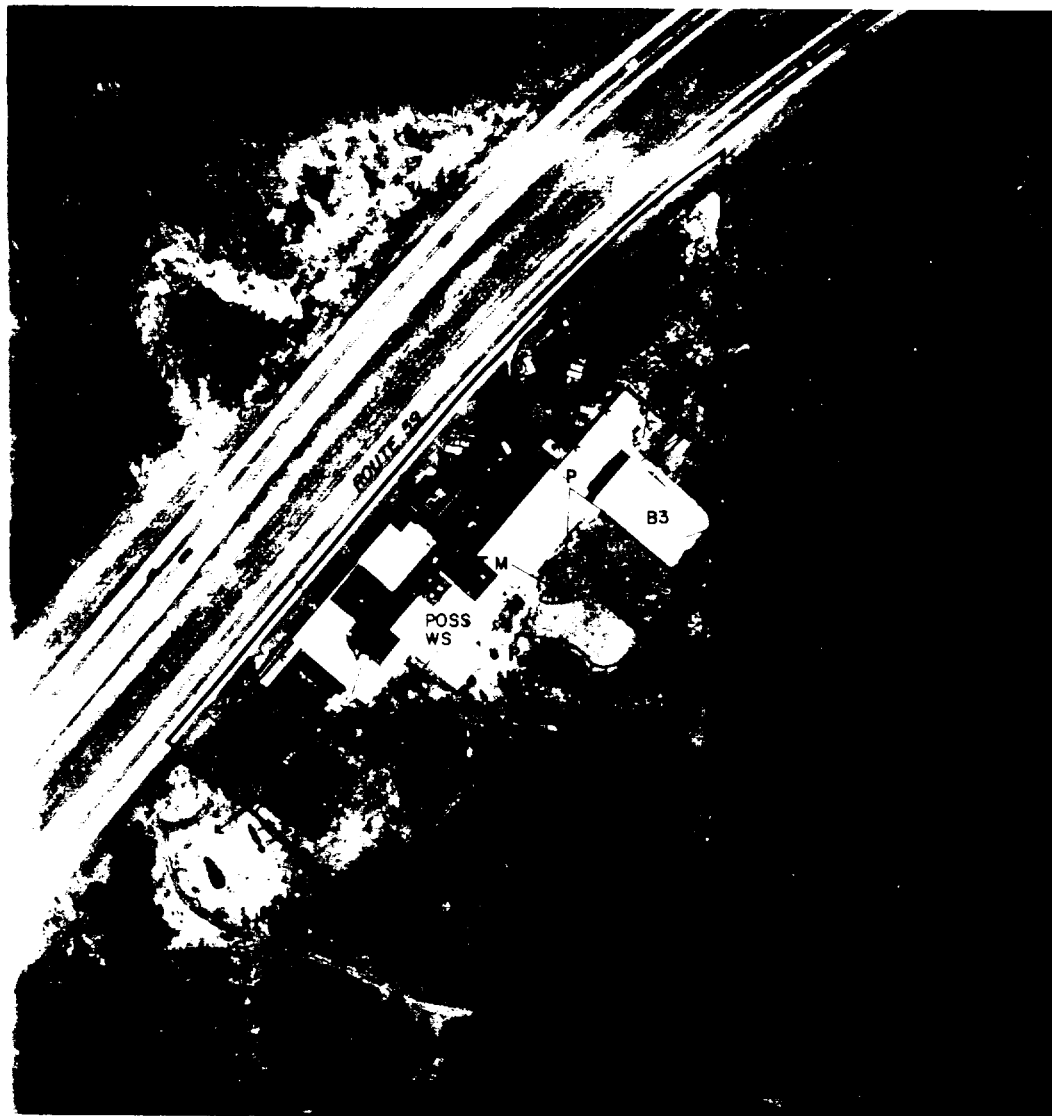
FIGURE 9
MILL MANUFACTURING CO.

Two separate groups of drums are present north of B3. One group contains approximately ten drums; the other, fourteen. A group of possible containers is seen north of the drums. A vertical tank is located outside the fence, north of B1. One horizontal tank (HT) is seen on the east side of B3.

Medium-toned (MT) material has been piled in two areas along the site's eastern boundary and at the southeast corner of B3. Light-toned material is present farther south and appears to be composed of many coarse-textured objects.

The mounded material, in the former locations of L1 and L2, and seen first in 1988, is clearly visible on the 1991 photography. The mound continues west towards B1. Channelized drainage is seen north of the mound, beginning at a pool of liquid and running east to Target Pond, where a ground scar was present in 1988. Whereas in 1988 the ground south of the mound appeared flat, it now appears to contain several smaller mounds (not annotated).

Pipes, possibly monitoring wells, have been placed in several locations around the mound. One is located just north of the pooled liquid connected to the drainage channel. A light-toned powdery material is seen next to the pool of liquid. A pipe and two probable pipes are south of the mound near two areas of wet soil. A fifth pipe is visible at the southwest corner of B3. All of these pipes protrude vertically from the ground.

An area of possible wet soil is seen south of B1, and light-toned possible refuse lies farther south of the wet soil.

The vertical tank alongside B1, first seen in 1988, is again visible. Light-toned powdery material is located adjacent to this tank. Three possible containers, seen in 1988, no longer exist onsite.

A dark-toned vegetated mound is visible where L3 had been in 1984 and a ground scar was seen in 1988. The large mound and probable channelized drainage, present in 1988, remain. An area of possible wet soil is seen where the probable channelized drainage begins.
